Integrating the Ecosystem Services approach in planning and operational activities affecting river hydromorphological processes

Sediment replenishment on the Buëch river (downstream of the St-Sauveur dam)

Buëch restoration site

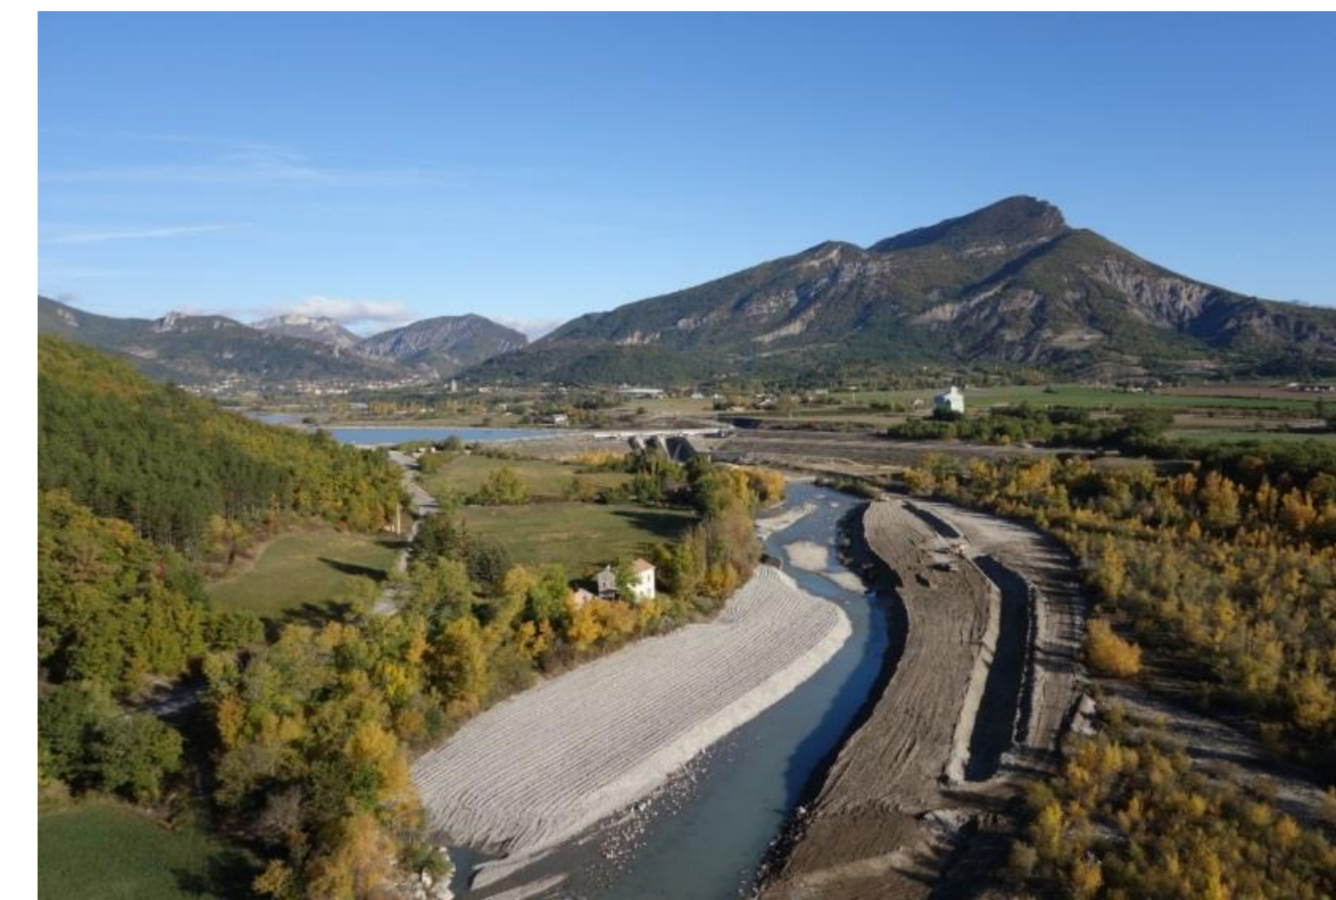
- Duration: 8 weeks from 09/2016
- Dredging the alluvial fan of the Saint Sauveur reservoir
- Sediment replenishment downstream of the dam 44,000 m³
